Project No. TS - 4993

Memorandum

RE: Olympic Drive Tree Retention Analysis – Ferry Terminal Access Road
Improvements

DATE: May 18, 2017

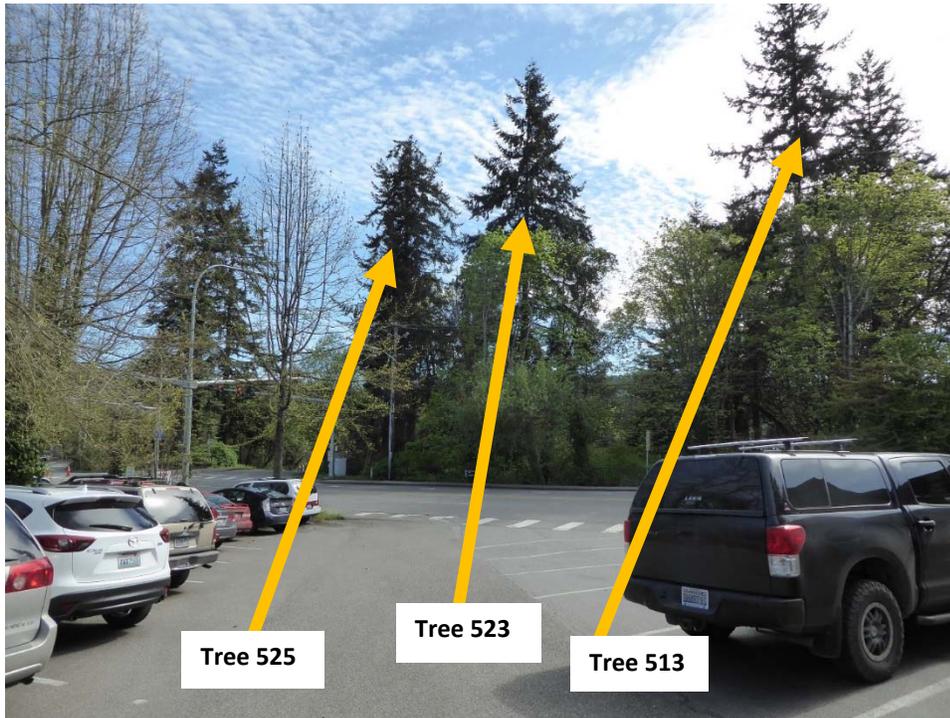
I assessed three trees, numbered 525, 523, 513 (Photo 1). These were originally proposed for removal with one tree (523) to be left as a snag in a report generated by our office. Due to concerns raised by the public we were asked to assess if there might be a way to retain the trees.

Photo 1. The subject trees looking south.

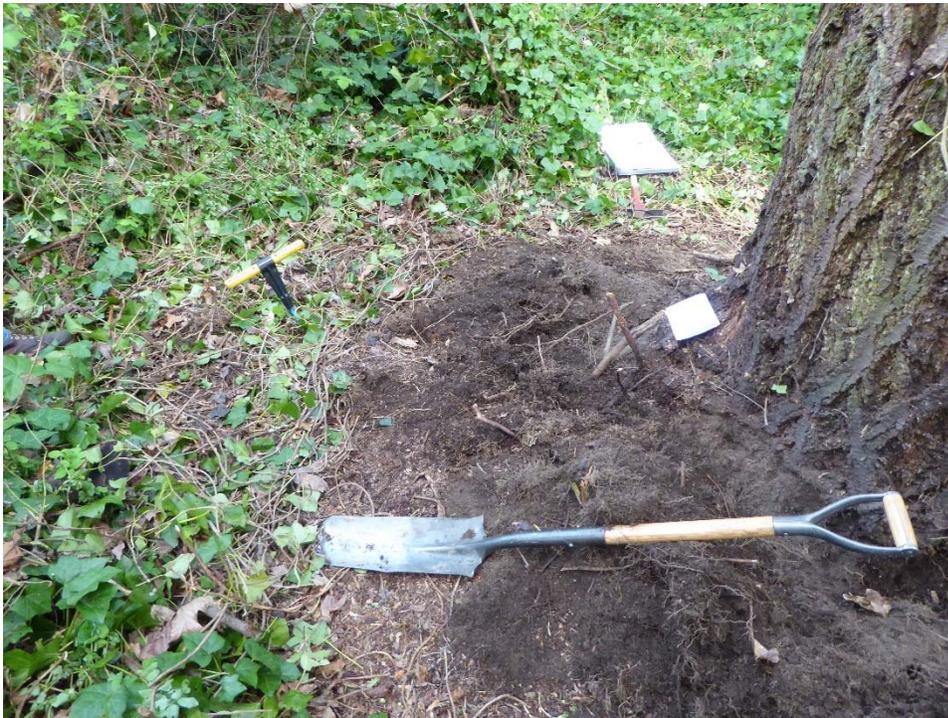
We used a soil probe to determine that the soil depth which could support trees roots is approximately 40 inches or greater, to the north side of the subject trees (Photo 2).

Photo 2. Base of tree 523 with soil probe fully inserted on wall side of the tree, an indication that there is likely good rooting depth.
